Technical Report ARAEW-TR-05007

ALTERNATIVE CARTRIDGE CASE MATERIAL AND DESIGN

Jerry S. Chung
Frontier Performance Polymers Corporation
26 Robert Street
Parsippany, NJ 07054

May 2005

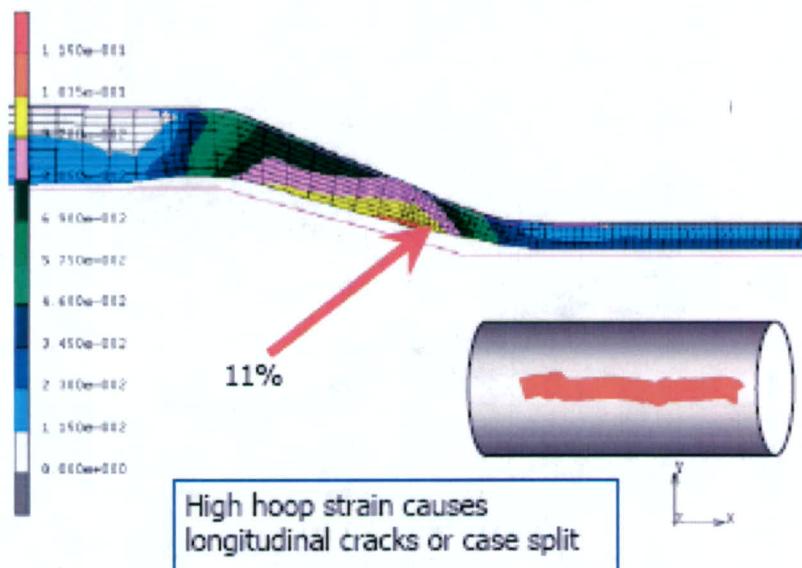
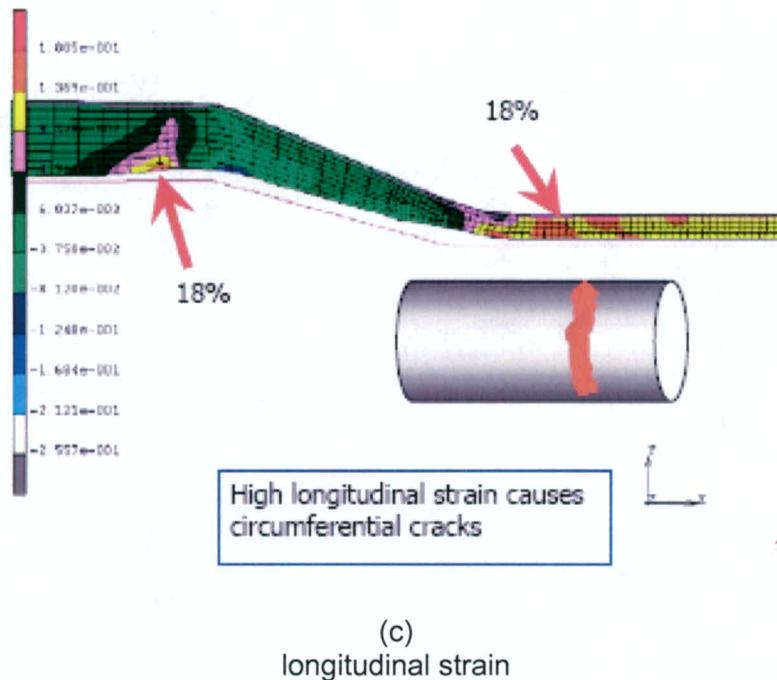
Figure 3
Polymer case made of the 30% glass fiber polymer under the ballistic pressure of 50,000 psi

The principal strain of the polymer case made of the 30% glass fiber polymer under the ballistic pressure of 50,000 psi is shown in figure 3(a). Since the principal strain consists of hoop strain (which may cause longitudinal crack at the case mouth or case split) or longitudinal strain (which may cause circumferential crack), it is important to separate these two strains to identify the potential failure modes. The hoop strain and longitudinal strain of the polymer case made of

30% glass fiber filled polymer are shown in figure 3 (b) and (c), respectively. The Finite Element Analysis (FEA) simulation results indicate that both the longitudinal and hoop strains (11 to 18%) are much higher than the 2 to 4% elongation-to-break of the 30% glass fiber polymer. The polymer case will fracture into pieces at the neck, shoulder, and mouth areas.

As the polymer becomes stronger, both hoop and longitudinal strains under the ballistic pressure becomes smaller, but nevertheless both strains are still higher than 2.5% elongation-to-break of the 65% glass fiber filled polymer. Thus, polymer case made of the 65% glass fiber filled polymer would fail and fracture.

It is important to point out that the mechanisms of two common failure modes of the polymer case can be predicted by the FEA simulation as shown in figures 3 and 4. The longitudinal crack is created at the location during the transition from case shoulder to case neck, and can result in case split as shown in figure 4(b). On the other hand, the circumferential crack is created at the location at the transition areas from the straight case body to the case shoulder as shown in figure 4(c). These observations can be confirmed by the failure modes of many test firings from the past polymer case developments.

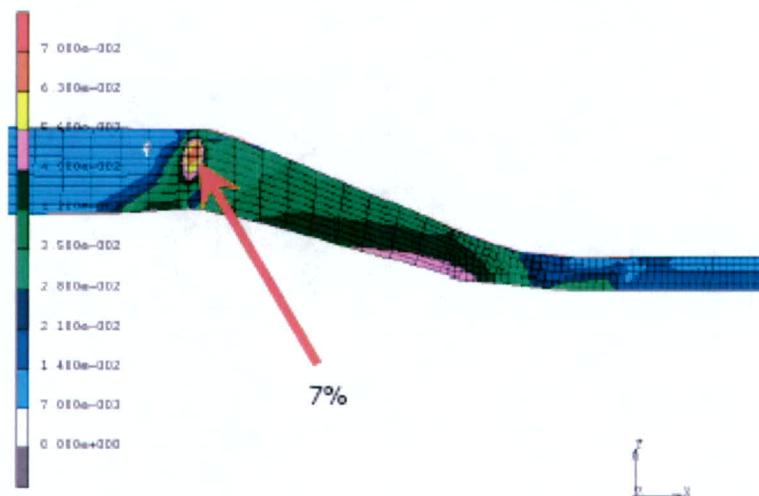
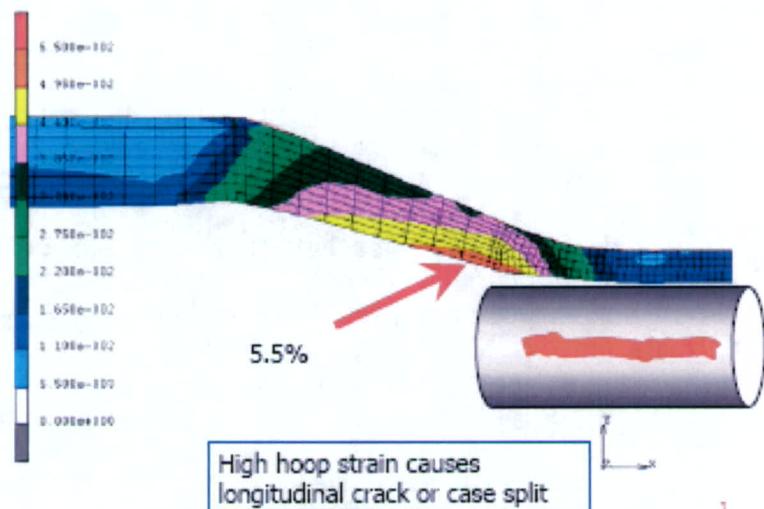
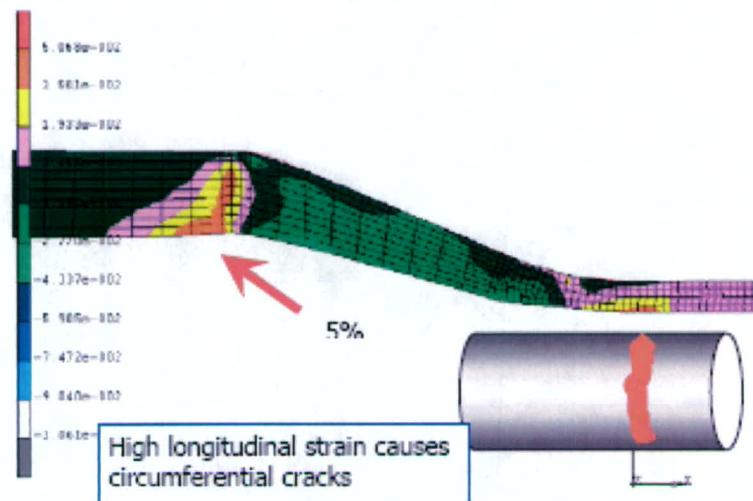
Figure 4
Polymer case made of the 65% glass fiber polymer under the ballistic pressure of 50,000 psi

If the glass fiber filled content is increased from 30% to 65%, its tensile strength is also increased from 25,000 psi to 40,000 psi. The principal, hoop, and longitudinal strains of the polymer case made of the high strength polymer from the FEA simulation results are shown in figure 4 (a) through (c).

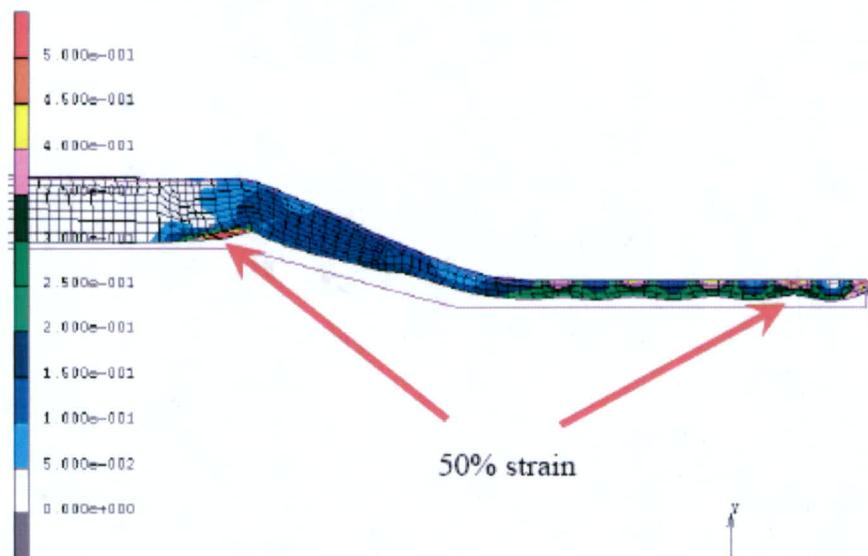
Figure 5
Tensile strain of the polymer case made of ductile polymer

Figure 5 shows the FEA simulation results of the high stress case shoulder and neck areas for a polymer case made of ductile polymers. It reveals that the highly compressible ductile polymer will be subjected to higher deformation than glass fiber filled polymers under the ballistic pressure. Thus, it is important that the ductile polymer have high elongation-to-break at temperatures from -65°F to 165°F . It is a challenging task to find a high temperature polymer material that has an elongation-to-break consistently higher than 50% at the desired temperature range. Despite that fact, Frontier has proved that it is possible to modify high temperature engineering plastic to achieve high elongation.
